Pueblo Depot Activity  
Pueblo (vic.)  
Pueblo County  
Colorado

HAER No. CO-22

WRITTEN HISTORICAL AND DESCRIPTIVE DATA

Pueblo Depot Activity

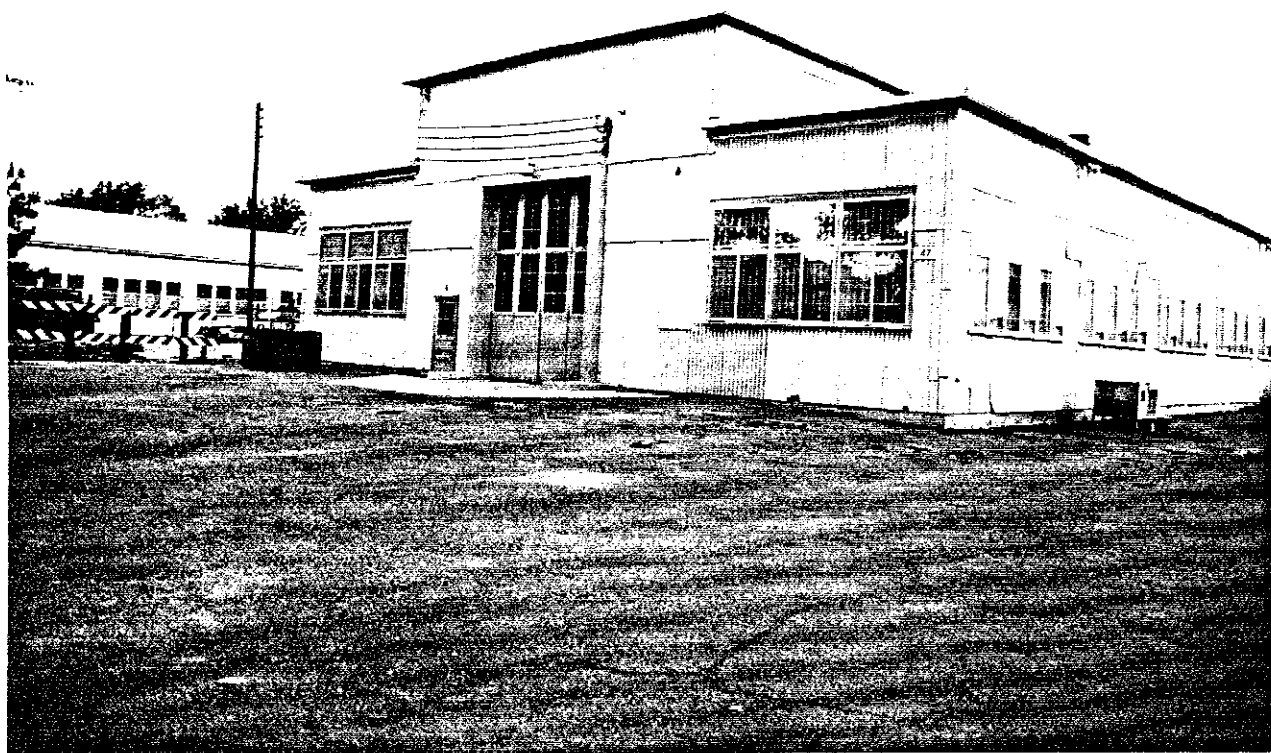
Figure 13: Originally constructed as a machine shop, Building S47 now serves as a roads and grounds facility. (Source: Field inventory photograph, 1983, Jeffrey A. Hess, MacDonald and Mack Partnership.)

extensive use of light, wood-frame, "mobilization" construction, which was "designed to last five years."<sup>11</sup> Structures in this category included the Post Headquarters (Building S1), Fire Station (Building S3), Health Clinic (Building S5), Officers' Residences (Buildings S11-S12, S25-S27), and Bachelor Officers' Quarters (Buildings T126, S127), Motor Repair Shop (Building S46), and Locomotive Repair Shop (Building S67) (Figures 8-14).

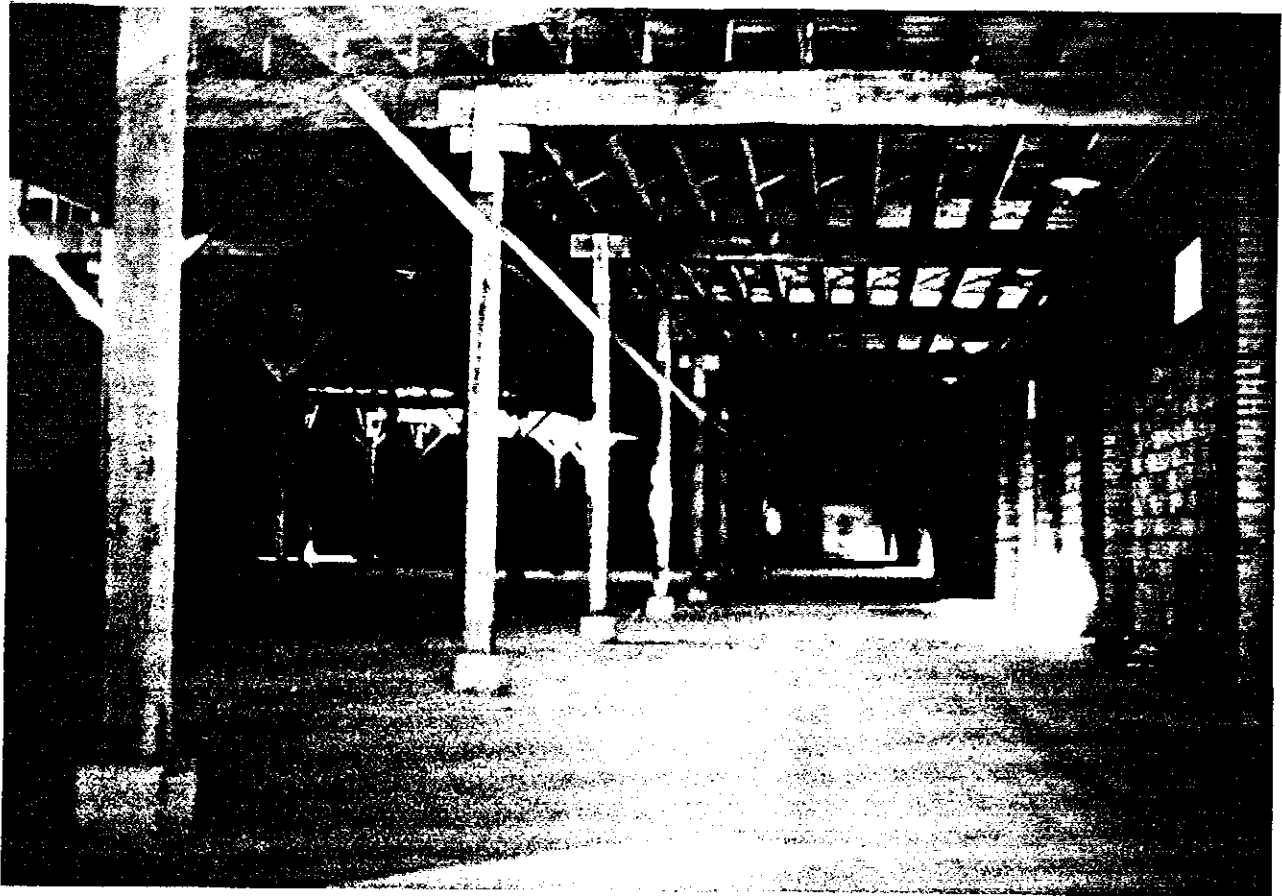
Figure 15: Wood framing employed in depot's warehouses (Buildings 525-528, 541-544, 552-555). (Source: "Completion Report, Pueblo Ordnance Depot," unpublished report prepared by U.S. Army Corps of Engineers, 1943, PUDA Facilities Engineer's Office.)

Facilities in the warehouse-and-shop area were designed to store and repair a variety of military supplies, including combat vehicles. Following general wartime specifications for depots, "warehouses [Buildings 525-528, 541-544, 552-555] [Figures 15, 16] were . . . of light frame construction, with fire walls only where necessary, with roofing specifications not to exceed a 10-year limit, and without excessive roof spans; sheds [Buildings S575-S578, S580-S584, S590-S594] [Figure 17] were . . . of open-type light frame construction without concrete floors."<sup>12</sup> The most durable structures in this area of the depot were four ordnance repair shops (Buildings 547, 548, 550, 551) (Figures 18, 19), which exhibited steel framing and corrugated-metal siding and roofing.

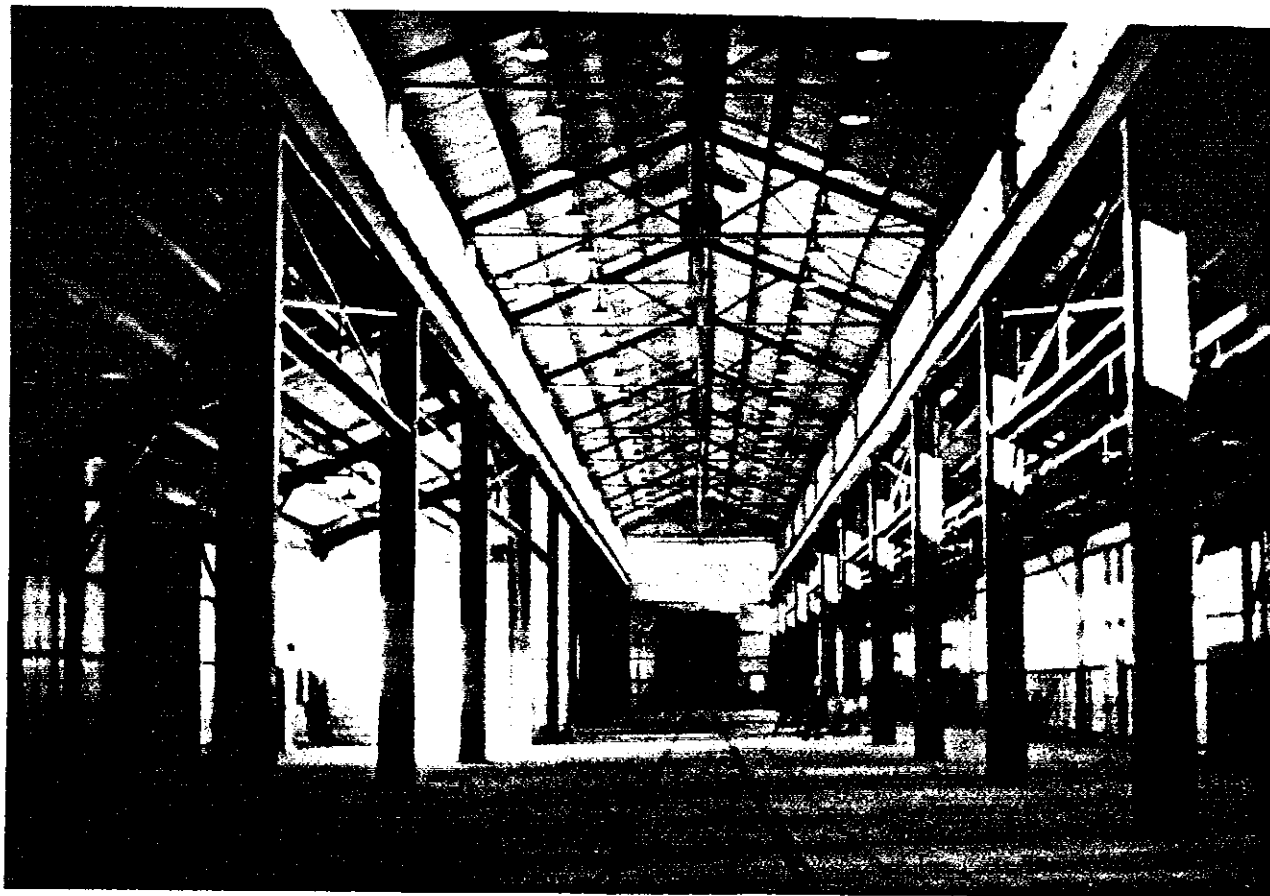
Figure 18: Interior view of Building 547, one of the ordnance repair shops constructed with steel framing. (Source: "Completion Report, Pueblo Ordnance Depot," unpublished report prepared by U. S. Army Corps of Engineers, 1943, PUDA Facilities Engineer's Office.)

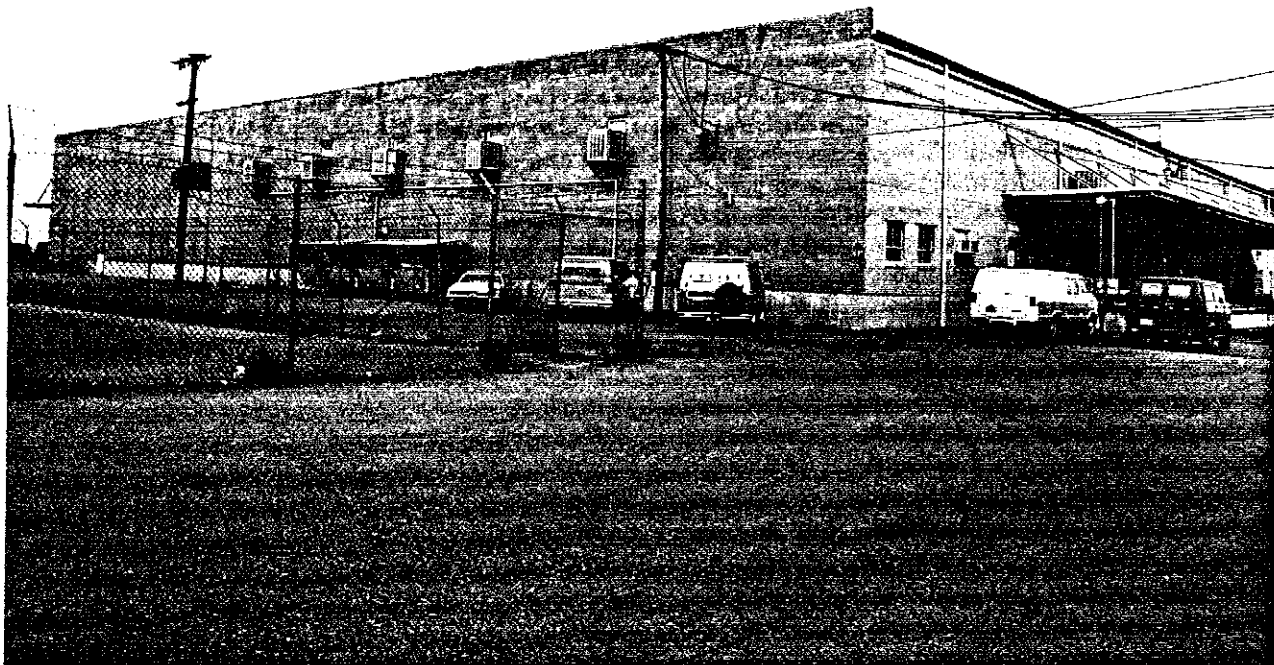
Figure 23: Constructed in the warehouse-and-shop area in the late 1950s, Building 529 was the depot's first missile maintenance facility. (Source: Field inventory photograph, 1983, Jeffrey A. Hess, MacDonald and Mack Partnership.)
